AFWAL-TR-81-2042

HIGH FRACTURE TOUGHNESS BEARING DEVELOPMENT

SKF Technology Services
SKF Industries, Inc.
King of Prussia, PA 19406

Final Report for Period: 1 April 1979 to 30 September 1981

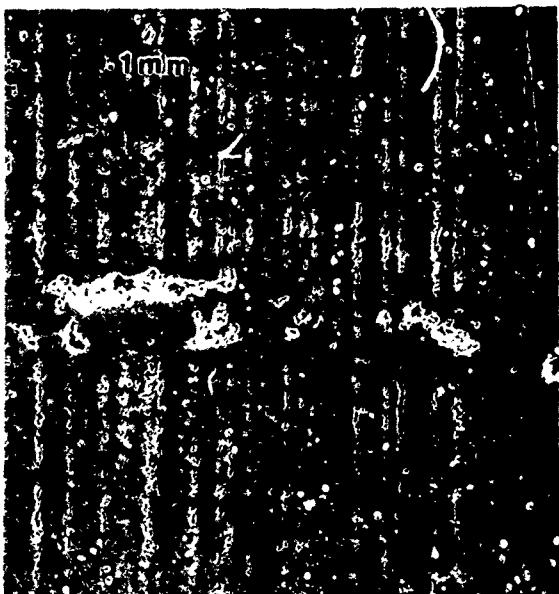
Figure 13 is a similar series of micrographs of the surface of the second ring that was tested for five hours. The same pattern of aligned cross-groove micro-pits is observed.

Figure 13. SEM Micrographs Showing Cross-Groove Orientation of Micro-Pits in Ball Path of EB Hardened Inner Ring (Bearing #331-202, Five Hours on Test)

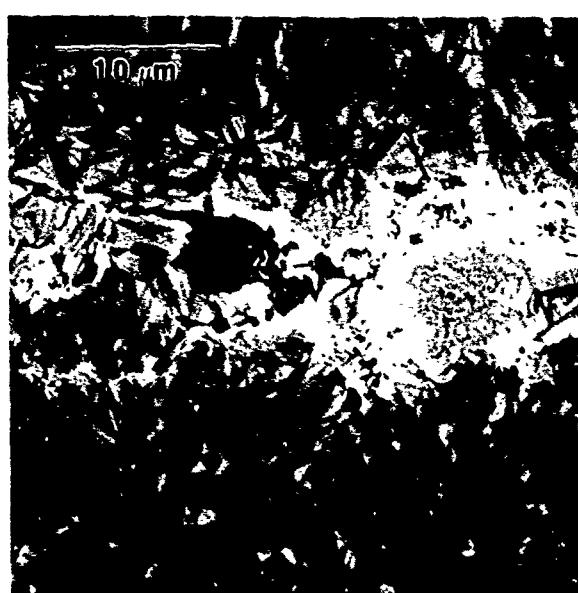
Figure 18 contains high magnification scanning electron micrographs of a metallographically prepared section of an EB hardened inner ring. Carbide dissolution, pits, which appear to be former carbide residences, and grain boundary outlining are apparent. The dark appearance of the grain boundaries in the backscatter images indicate grain boundary separation (i.e. cracking).

Figure 18. SEM Micrographs Showing Pit (Former Carbide Residence, Dissolved Carbide (White) Areas in A & C) and Apparent Grain Boundary Separation
